# Assessment of Dam Safety

## Coal Combustion Surface Impoundments (Task 3)

American Electric Power

Big Sandy  
Generating Station

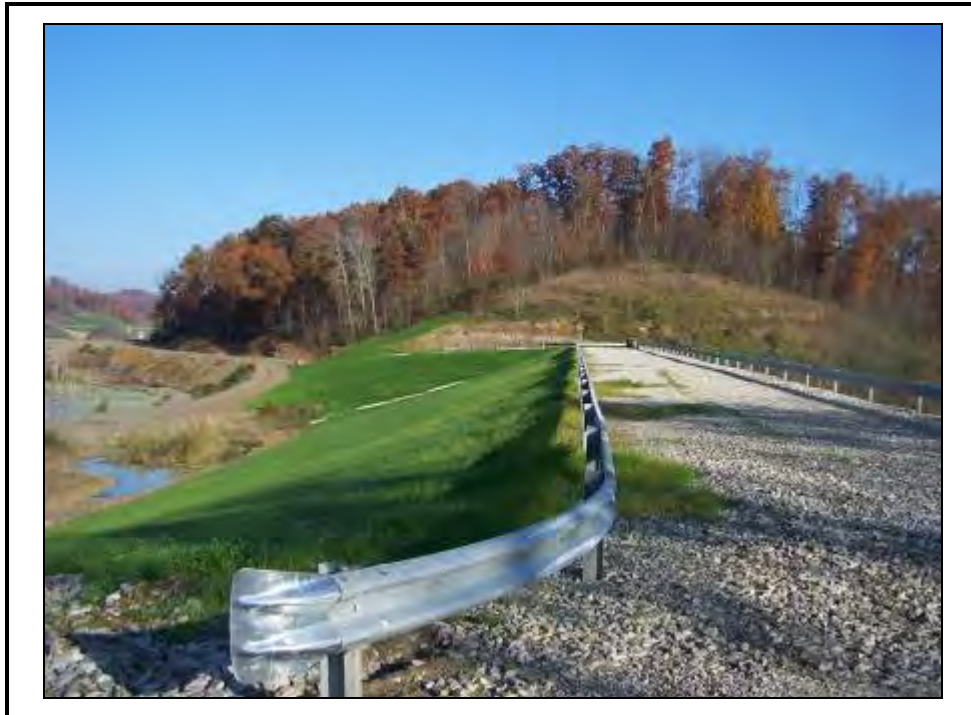
1

Crest and upstream slope of Saddle Dam, looking north.

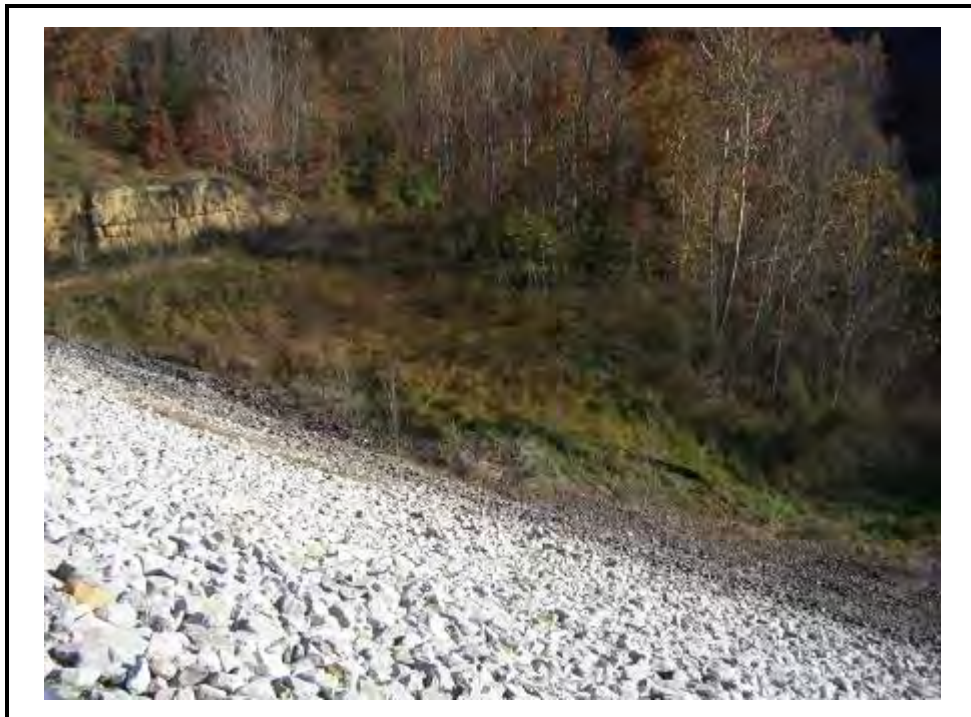
4

North downstream groin of Saddle Dam looking northeast. Bedrock in upper left is part of original emergency spillway channel which is now plugged.  
Note small trees in groin have been sprayed with herbicide.

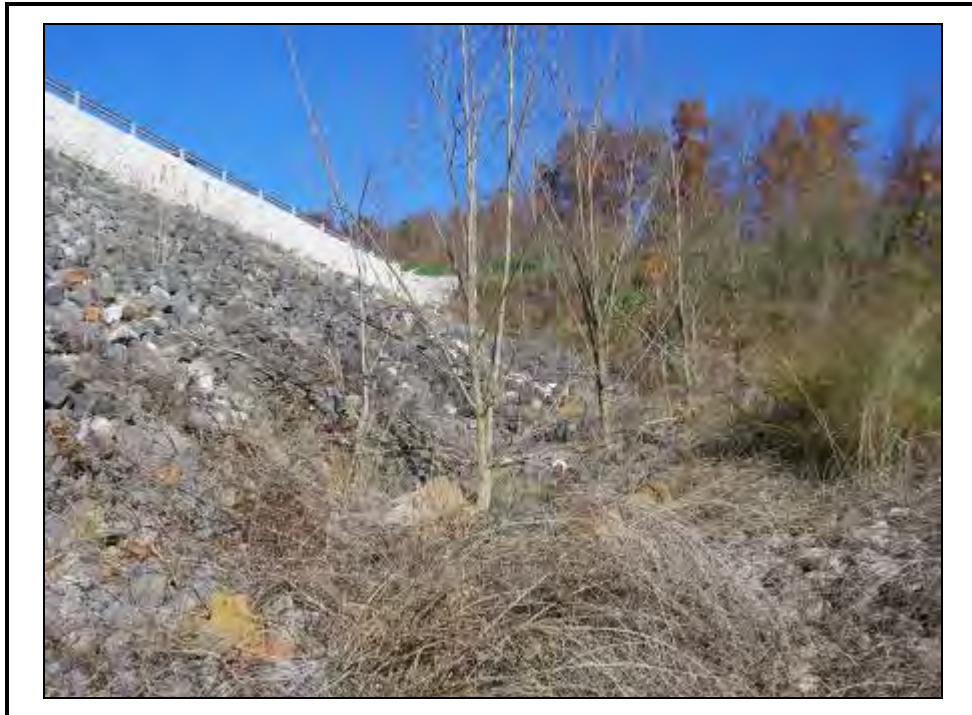
5

Close-up of trees in north downstream groin.

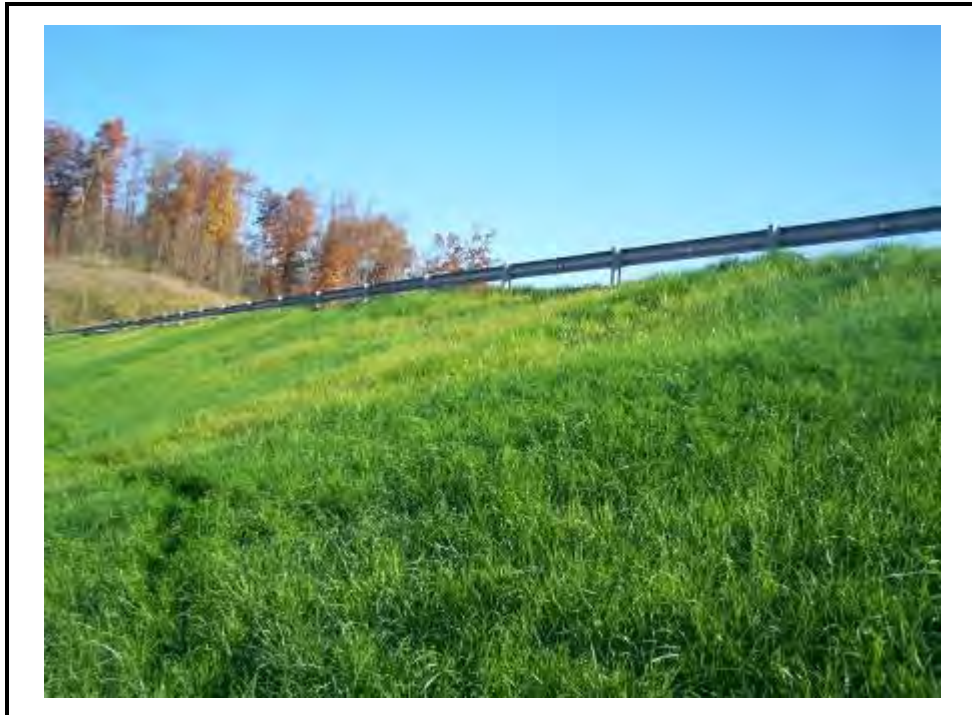
9

The upstream and downstream slopes were reasonably uniformly graded. The grass cover on the upstream slope appeared well maintained as shown in Photo 1. As shown in Photo 9, there is some grading irregularity on the south end of the upstream slope where the upstream slope meets the crest. The stone covered downstream slope appeared generally clear of vegetation as shown in Photo 2. However, brush and small trees were observed within the stone at the south and north groins (Photos 2 through 6). Plant personnel indicated that the small trees have been sprayed with herbicide.

Irregularity to grading at upstream slope/crest intersection on Saddle Dam.

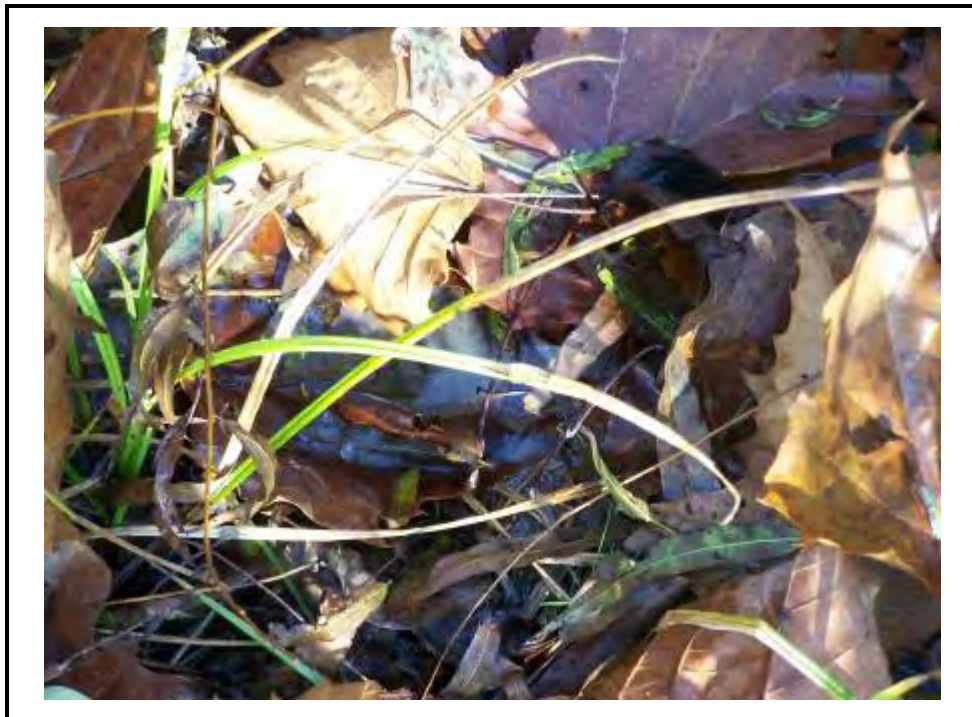
10

Toe drain outlet from under main portion of Saddle Dam.  
Note the pipe is covered with vegetation.

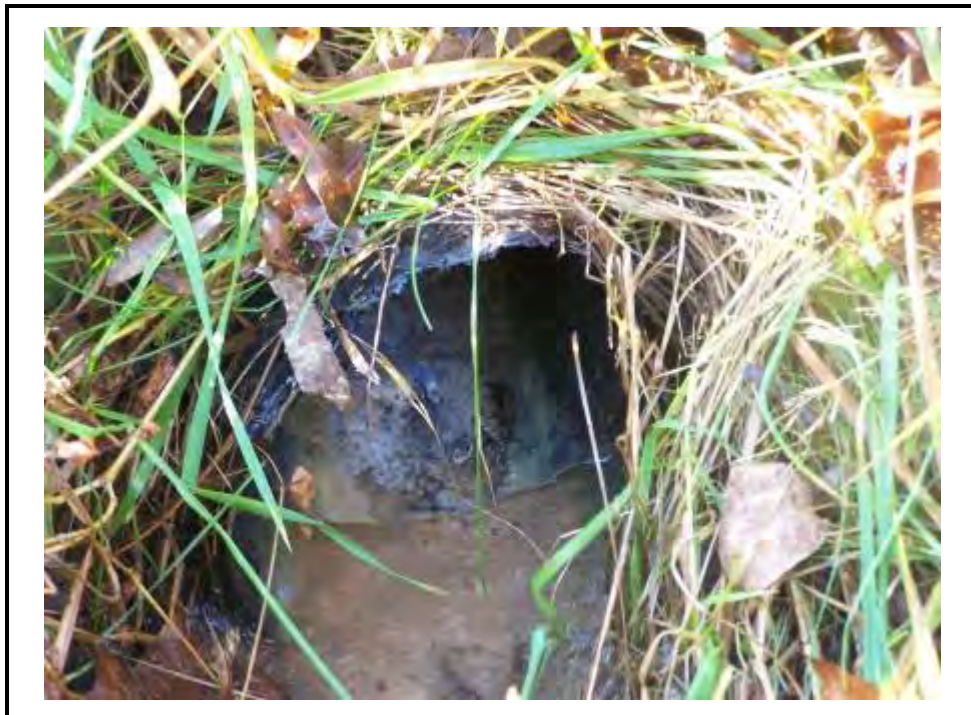
11

Toe drain outlet after clearing vegetation.

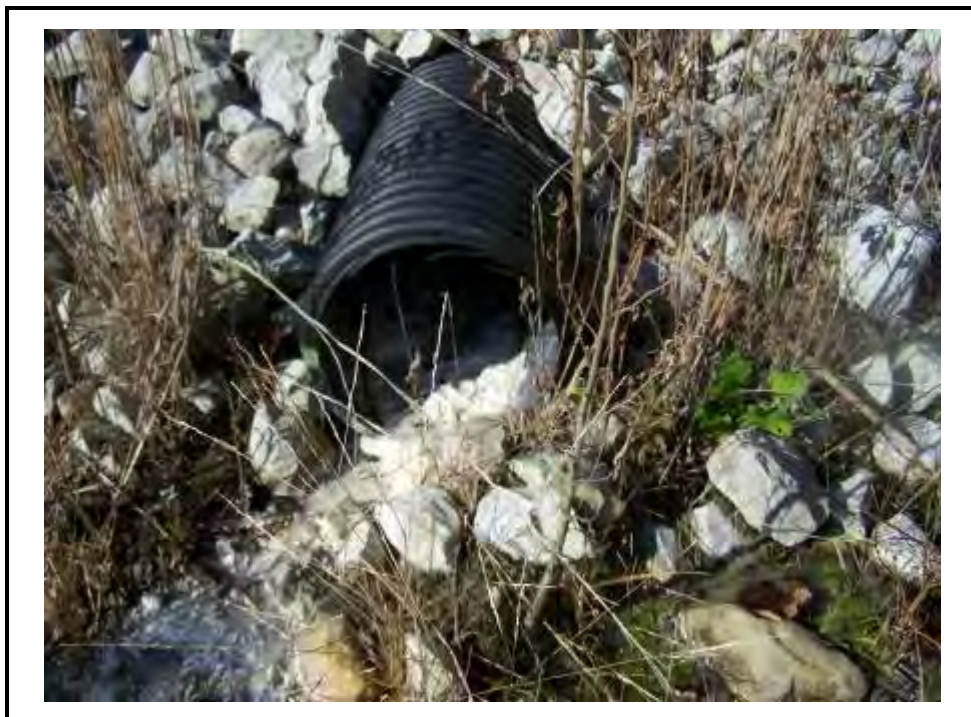
14

Seepage drain from original emergency spillway plug.  
Note calcium deposits from granular fill used in filter blanket.

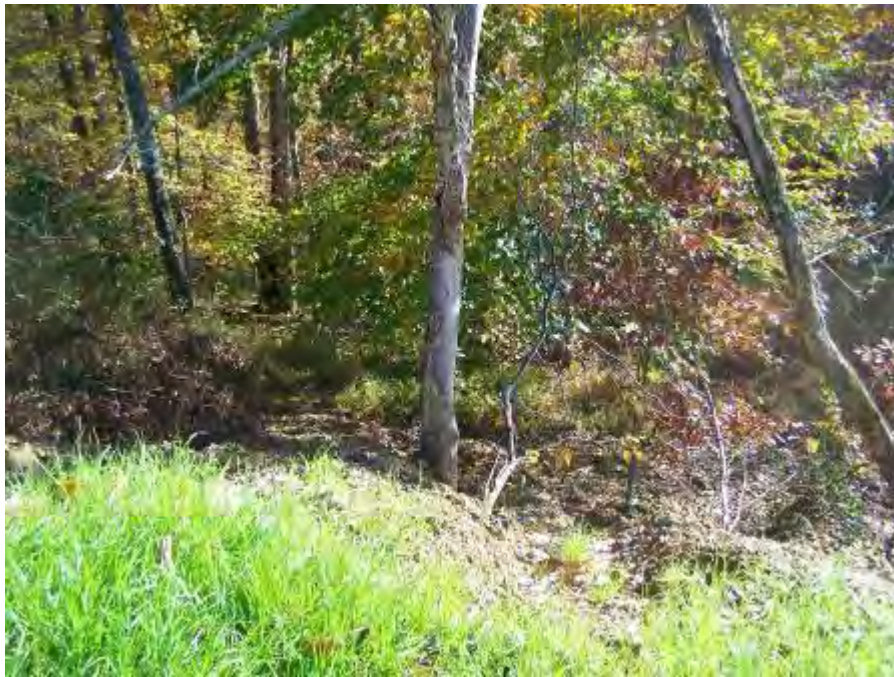
17

Downstream condition of “new” emergency spillway.

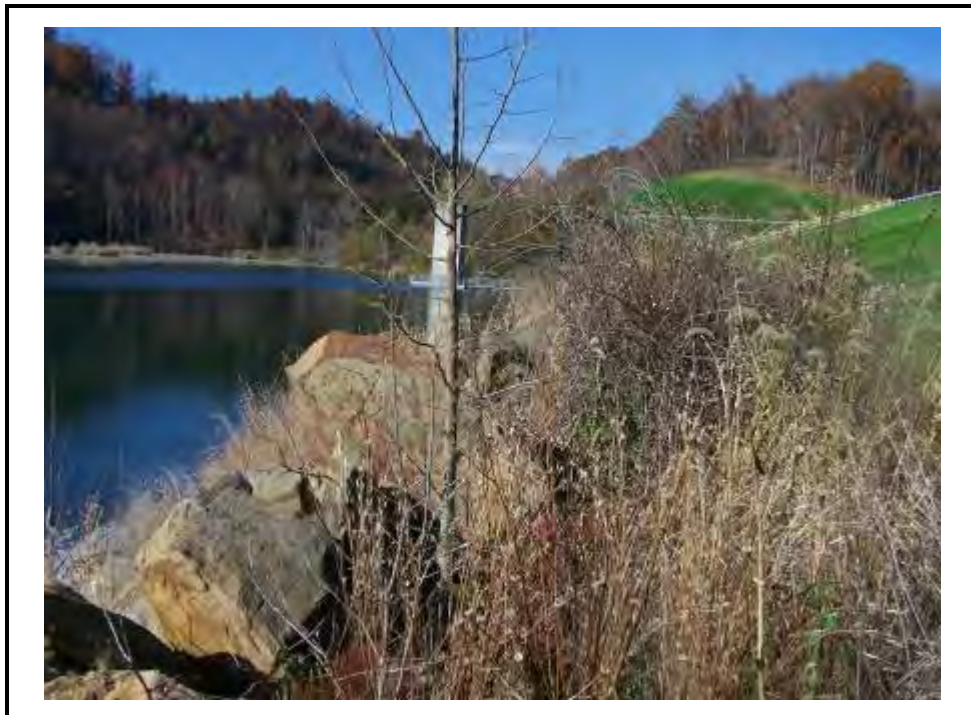
28

Brush and small trees in rip rap along the water line have been sprayed with herbicide at Horseford Dam

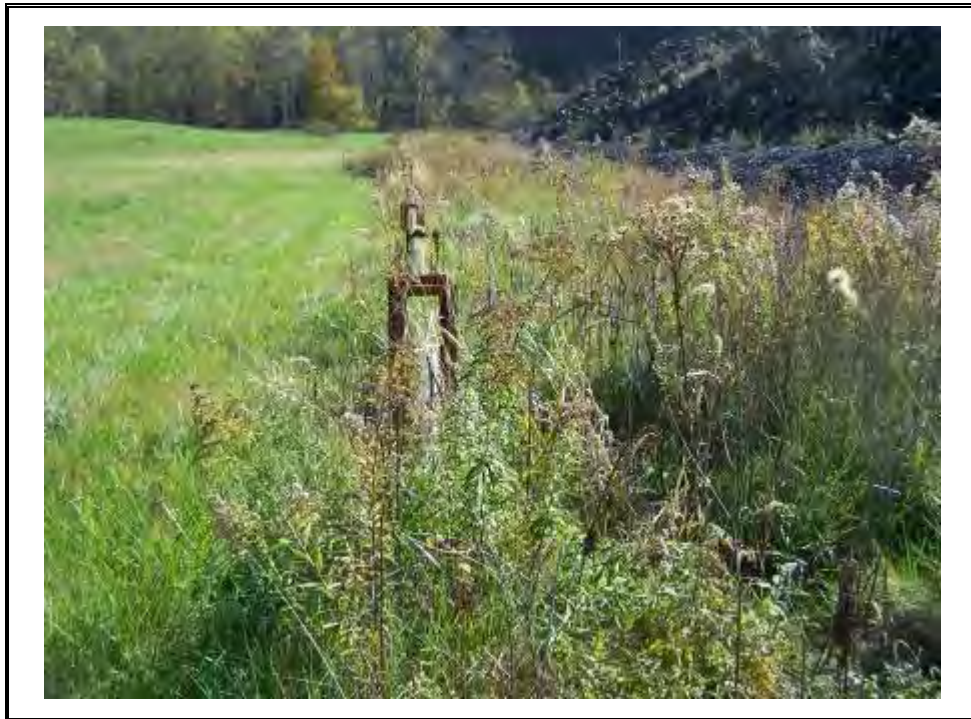
37

Relief wells part of Horseford Creek Dam toe drain system.  
Area in taller grass is wet from seepage.

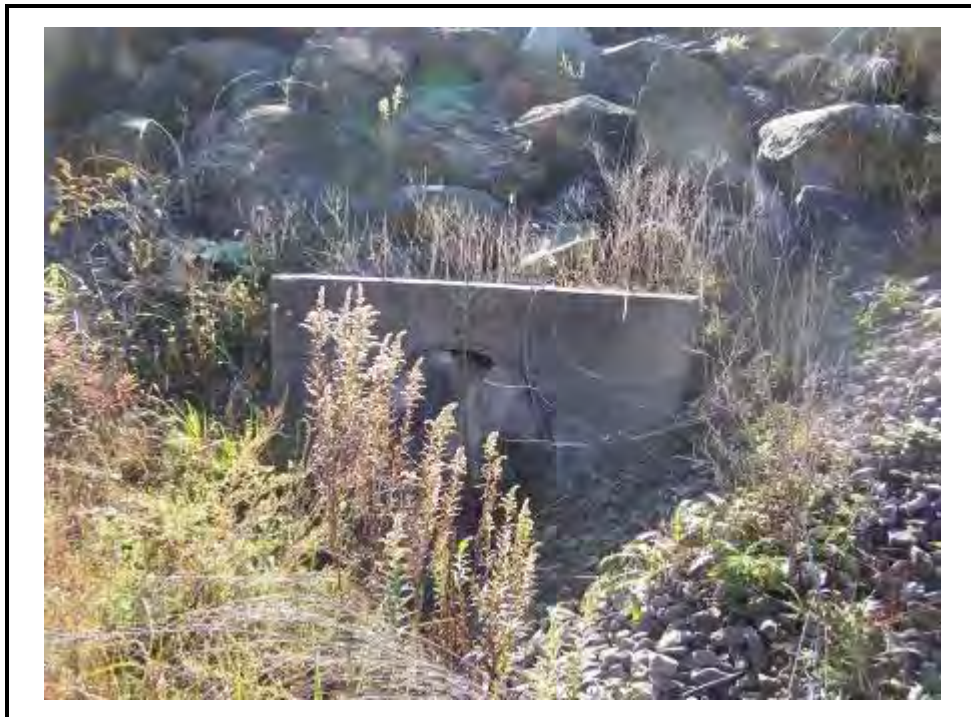
38

Phase I outlet pipe was abandoned in place.

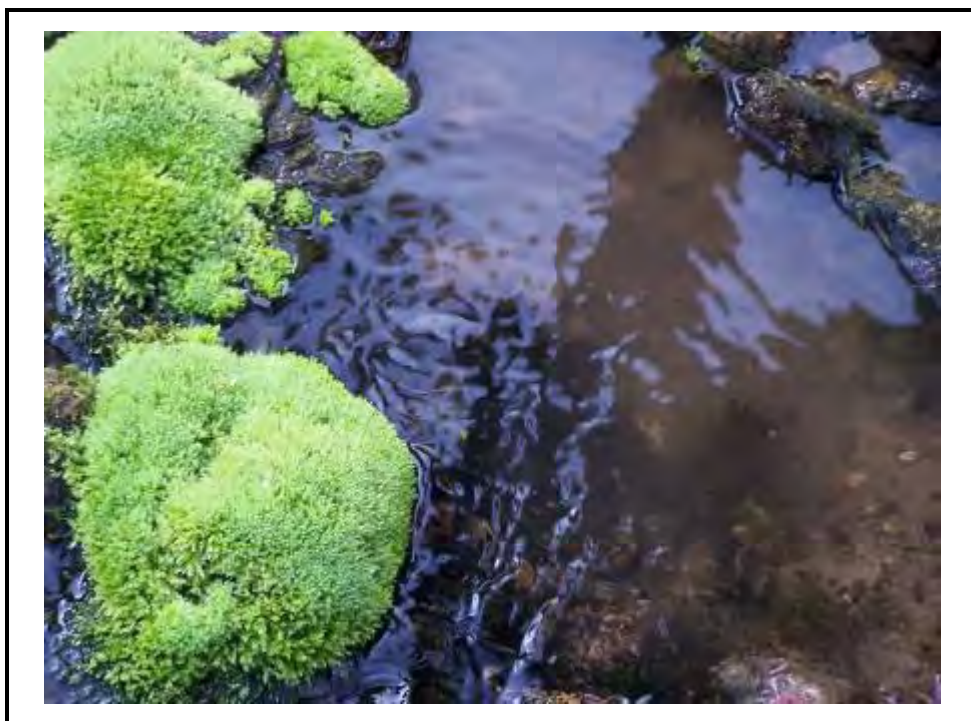
40

Toe drain discharge pipe is burried in sand and rock but flowing.

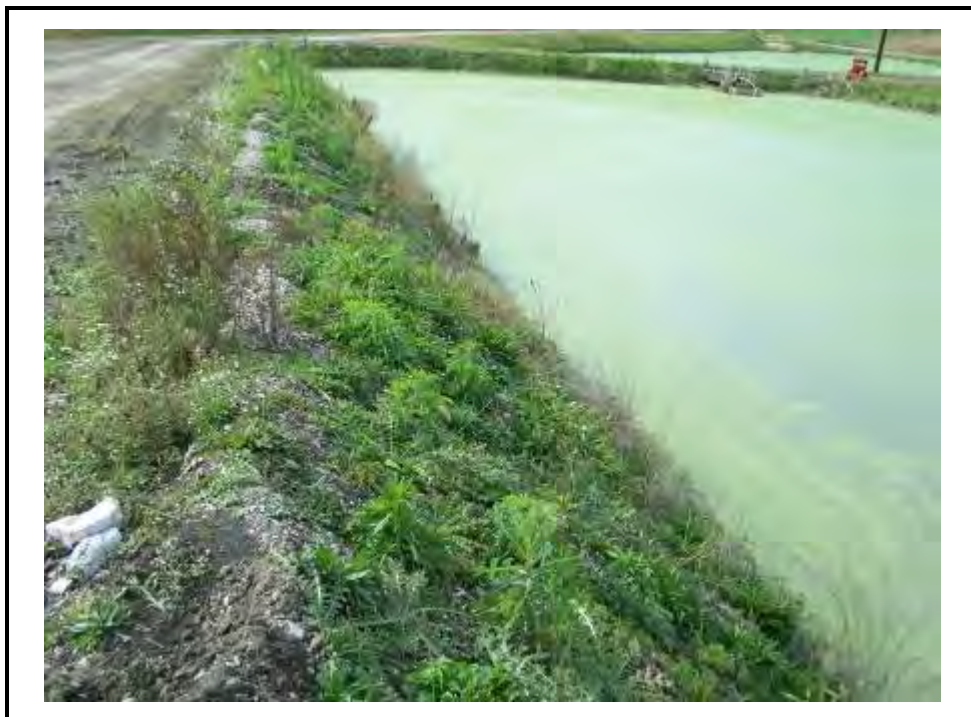
47

Sparse grass cover was observed on the downstream and upstream slopes of the south dike adjacent to the SCWP (Photos 46 and 47). Rip rap has been recently placed on the upstream slopes at the west end of the SCWP as shown in Photos 48 through 50.

Upstream slope of South Dike of Bottom Ash Complex at south Clearwater Pond, looking west.

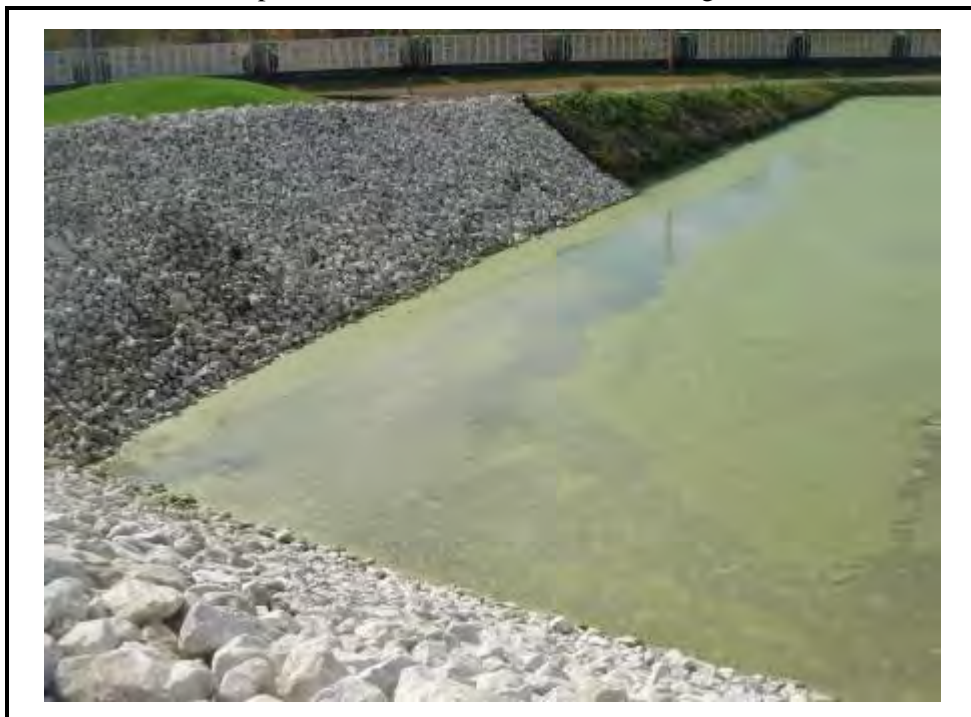
48

Upstream slope of South Dike of Bottom Ash Complex at south Clearwater Pond, recently placed rip rap protection at east end.

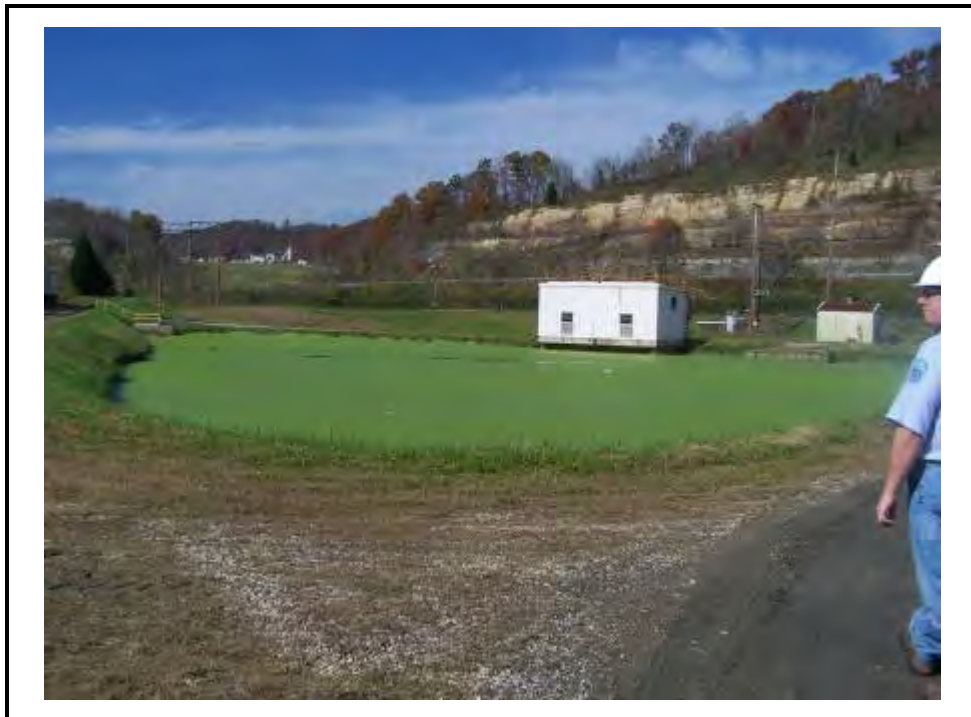
55

Reclaim Pond (incised) looking west. Building is the pump station which diverts flows back to the plant or to Horseford Reservoir. At west end of pond is a non-permitted overflow to the Big Sandy River.

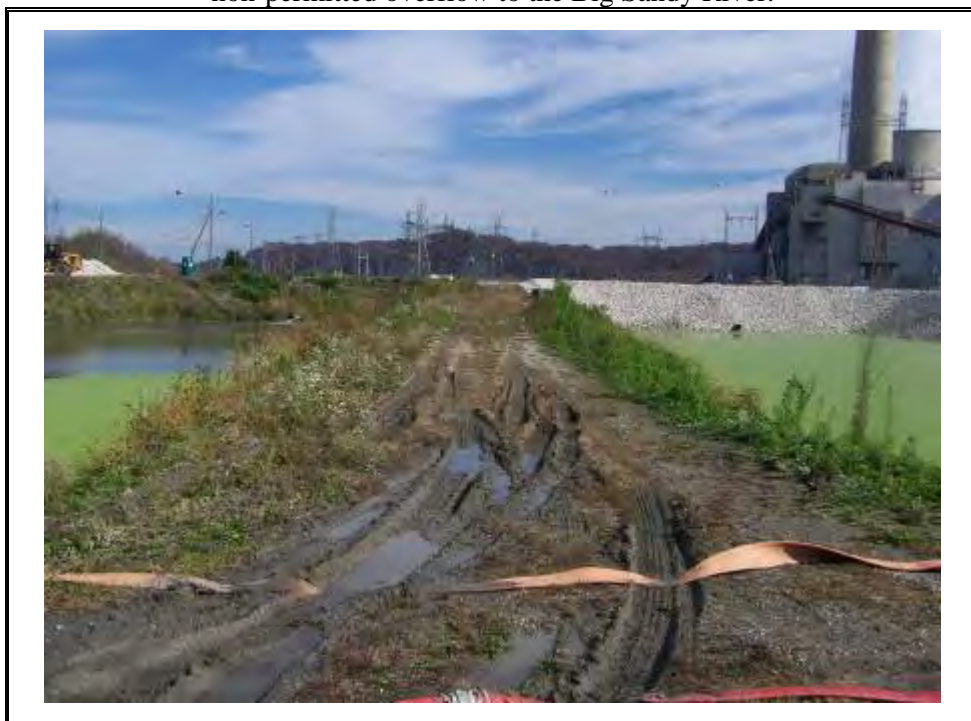
56

Standing water was observed in tire ruts on the crest of the splitter dike between the NCWP and SCWP as seen in Photo 56. Erosion has occurred at the water line on the northern toe of the splitter dike between the NCWP and SCWP due to wave action as seen in Photo 58. This mode of erosion is part of the reason for the current work to cover the slopes with grouted rip rap. Several bushes were observed growing on the west slope of the splitter dike between the NBAP and NCWP as shown in Photo 61. The crest of the splitter dike between the SBAP and SCWP is uneven as shown in Photo 63.

Crest of Splitter Dike between north and south Clearwater Ponds, looking east.

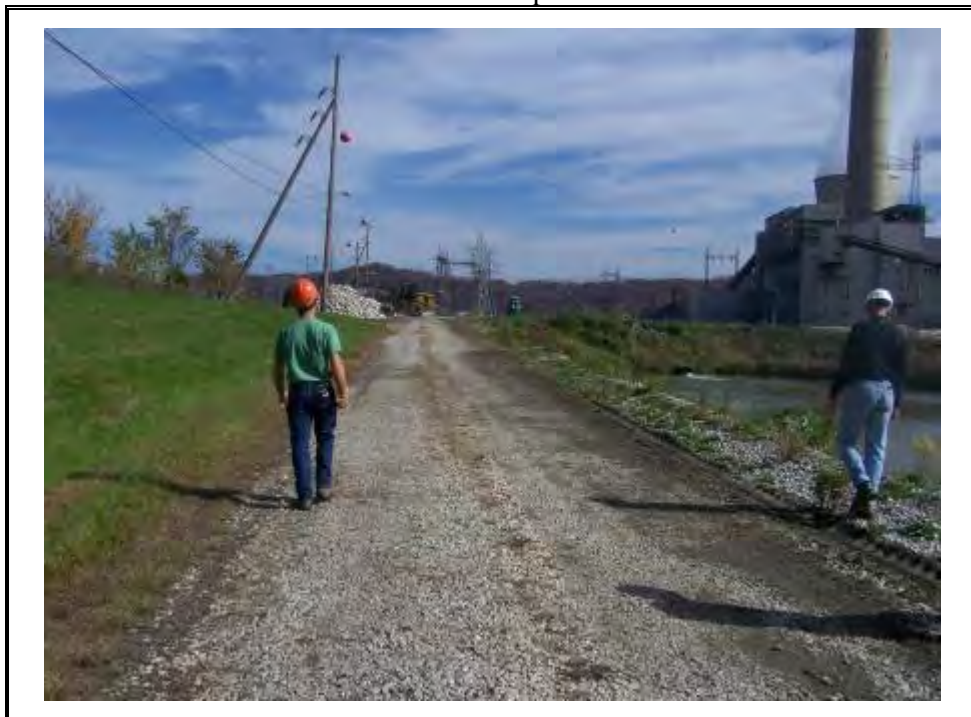
60

The western end of the north side of the NCWP is incised as shown in Photo 60. Tall grass was observed on the upstream slope of the north dike adjacent to the NBAP as shown in Photo 65. The standing water shown in the photo is from recent rain.

Crest of North Dike of Bottom Ash Complex along  
north Clearwater Pond where Bottom Ash Complex is incised.

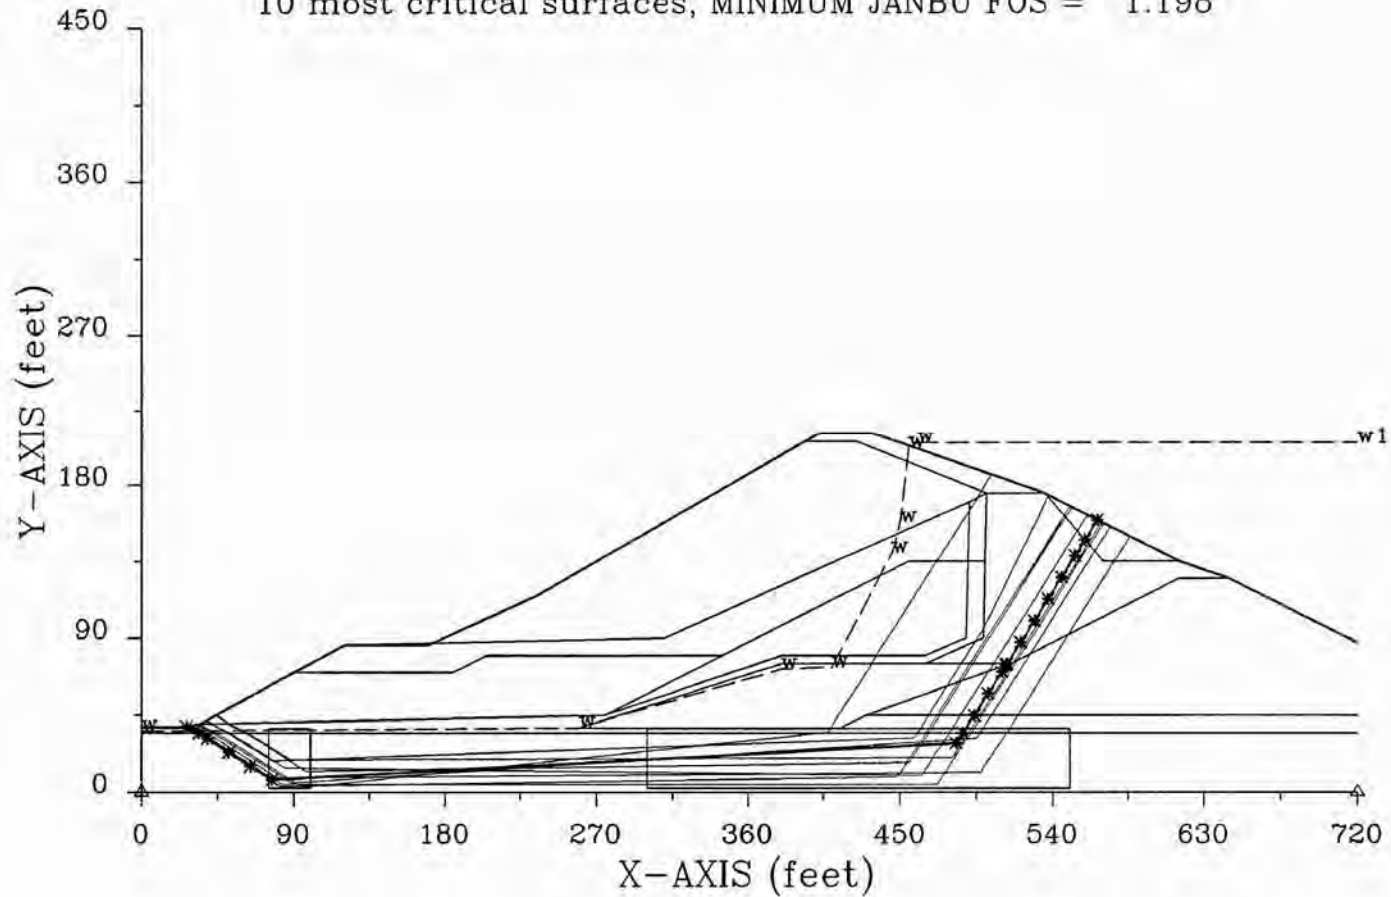
STEADY SEEPAGE MAX. STRG. PL. 705 EA  
10 most critical surfaces, MINIMUM JANBU FOS = 1.198

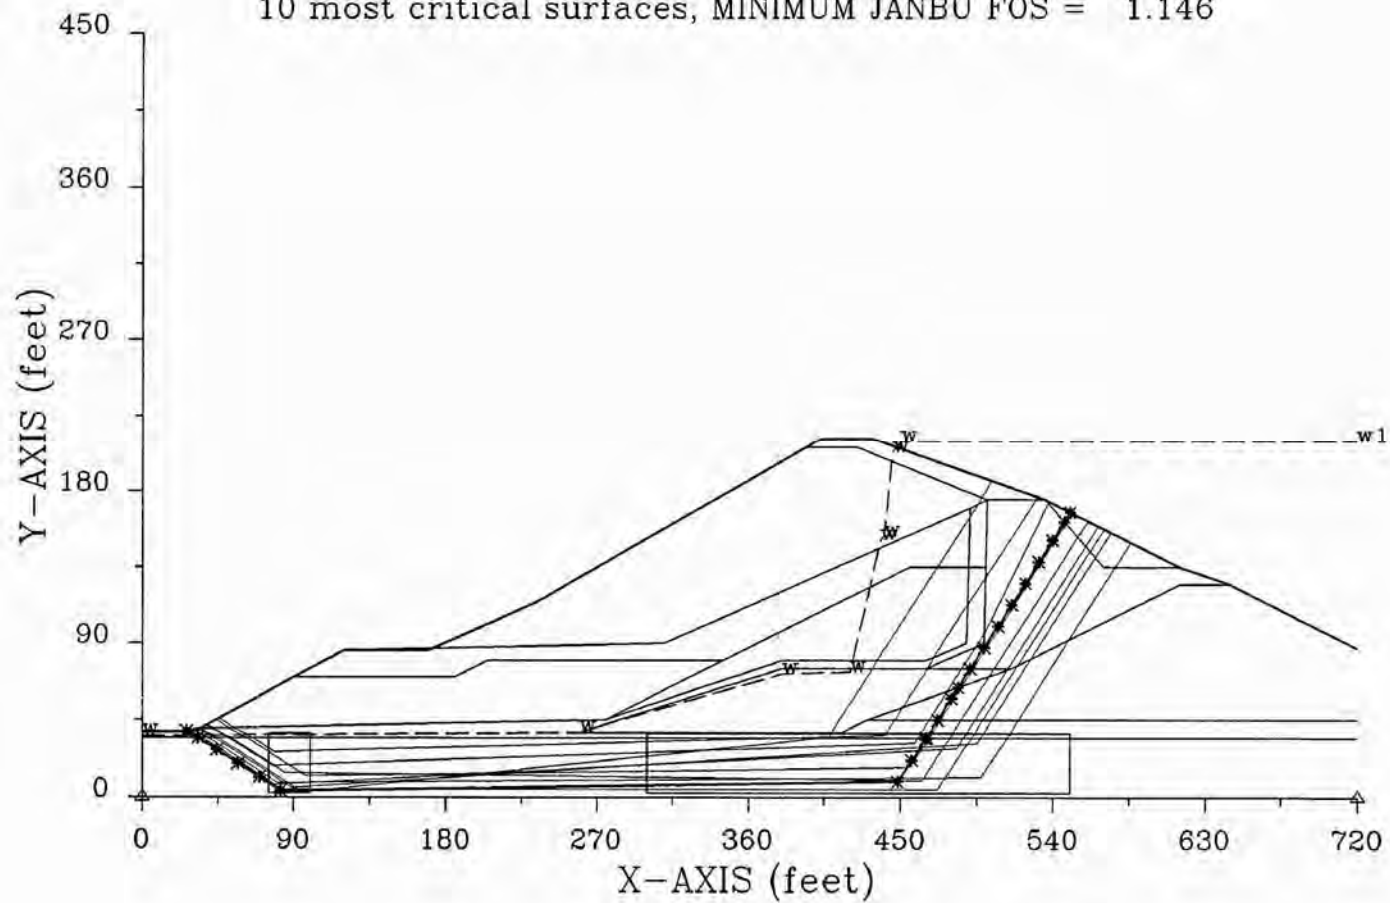
STEADY SEEPAGE SURCHARGE POOL 709 EA  
10 most critical surfaces, MINIMUM JANBU FOS = 1.146
